The Chiswick Curve Public Inquiry

Friends of Gunnersbury Park & Museum

4.2.3 Views

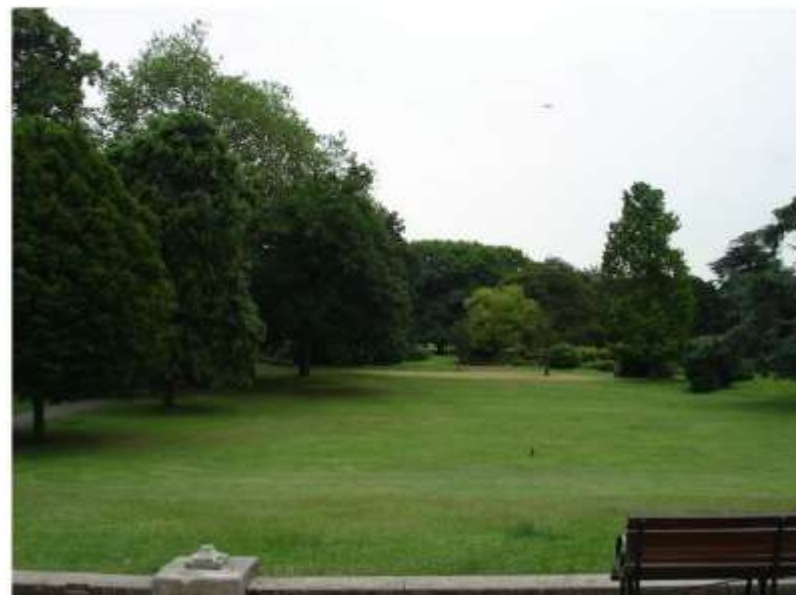
View 1 (View 9 in 2008 CMP)

From the Terrace outside Gunnersbury Park House, looking across the Park and Gardens

As a 17th or 18th century view, the present view is in poor condition with few visible features from either period and with a restricted view due to 19th century and municipal planting. The rockery within the earthwork of the Horseshoe Pond is an intrusive feature in this respect, obscuring the one surviving element from this period.

As a 19th and early 20th century view associated with the Rothschild mansion, however, the view is in fair condition, although the extent of municipal planting means that its original character has to some extent been compromised. The density of such planting also ensures that the view is probably more restricted than it was in the 19th century.

The increasingly restricted nature, over time, of the views out from the mansion and into the wider landscape constitutes one of the intrinsic aspects of Gunnersbury's historic character and is a reflection of the increasingly industrialised and urbanised character of the locality in the course of the 19th century.

CONDITION RATING 4 RECOVERABLE VIEW.

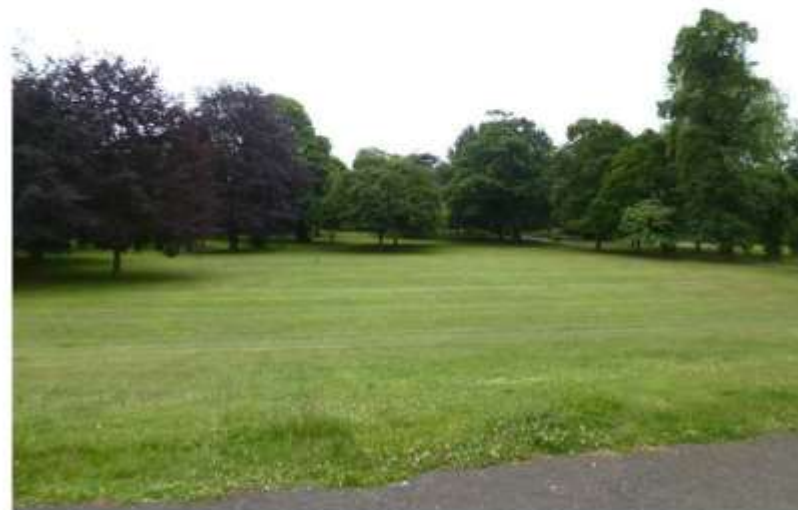
View 2 (Views 8 and 10 in 2008 CMP)

From the Terrace Outside the Small Mansion looking over the Gardens and Parkland

As a 17th or 18th century view, the present view is in poor condition with no visible features from either period and with a restricted view due to 19th century and municipal planting. Recent planting on the site of the Horseshoe Pond obscures the probable 19th century view over the gardens of the Small Mansion. The view is much more densely treed than it was in the 19th century, with modern groups of copper beech as a particularly prominent feature. Therefore, as a 19th century view this is also in poor condition.

Once again however, it is important to note that the increasingly restricted nature over time of the views out into the wider landscape, constitutes one of the intrinsic aspects of Gunnersbury's historic character and is a reflection of the increasingly industrialised and urbanised character of the locality in the course of the 19th century.

CONDITION RATING 4 RECOVERABLE VIEW.

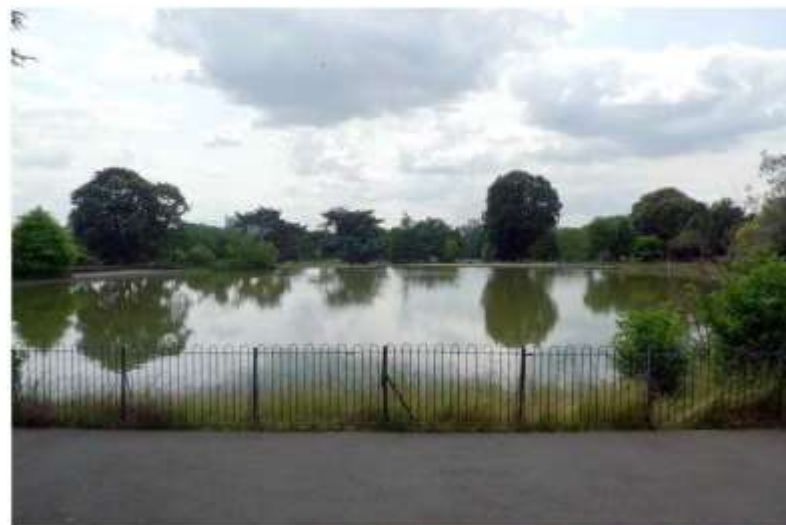
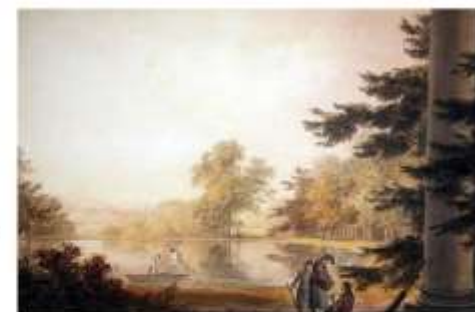
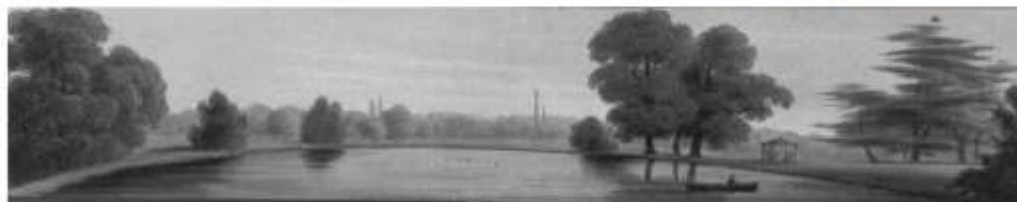
View 9 (View 5 in 2008 CMP)

From the Temple looking south across the Round Pond and Parkland

The view is in medium condition. The 19th century planting within the parkland detracts from the original view designed in the 18th century, although to a significant extent the mixture of deciduous and coniferous planting, and some of the particular hardwood species employed, probably serves to replicate the spirit of the original design. Moreover, the density of planting – which is almost certainly greater than in the 18th century – serves together with the perimeter belt to the south to partially screen a number of tall office buildings and high-rise flats south of the Park from the present view which are more intrusive than the later planting scheme. Once again we can see how views out into the wider landscape became increasingly restricted over time as the locality became more urban and industrial in character. The pond itself, the principal foreground to this viewpoint, and View 8, suffers from a lack of use – the original 18th century design and experience of the view was intended to be enlivened by activity and the variety offered by boating on the lake. Once again, the municipal iron fencing around the pond, although perhaps a necessary feature of the Park's present role as a public open space, serves to compromise the view. The filtered views across the Park are believed to be recoverable in time although intervening fencing is a big issue.

CONDITION RATING 2/4

EXISTING HISTORIC VIEW.

View across the Round Pond from the Temple (E. Kretschmar c.1847)

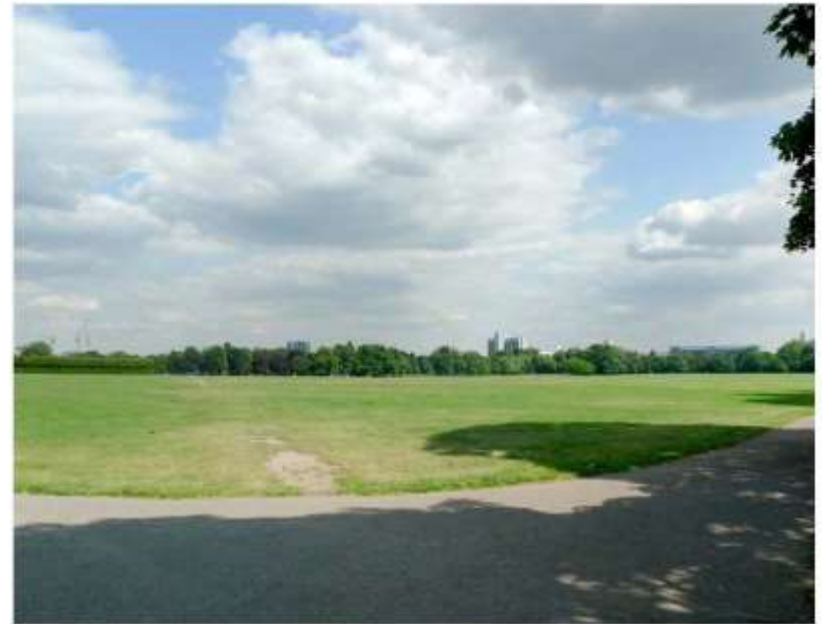
View 11 (Not included in 2008 CMP)

The Playing Fields from the Lionel Road Entrance

The view is in very good condition, with clear views across the playing fields towards the Model Farm and the southern edge of the Park. There are some intrusive high-rise buildings within the view, but the planting does screen out other development. Although the planting visible within the view mainly dates from the 20th century, the current view gives a fair impression of the appearance of this part of the Park in the late 19th century.

**CONDITION RATING I
RECOVERABLE.**

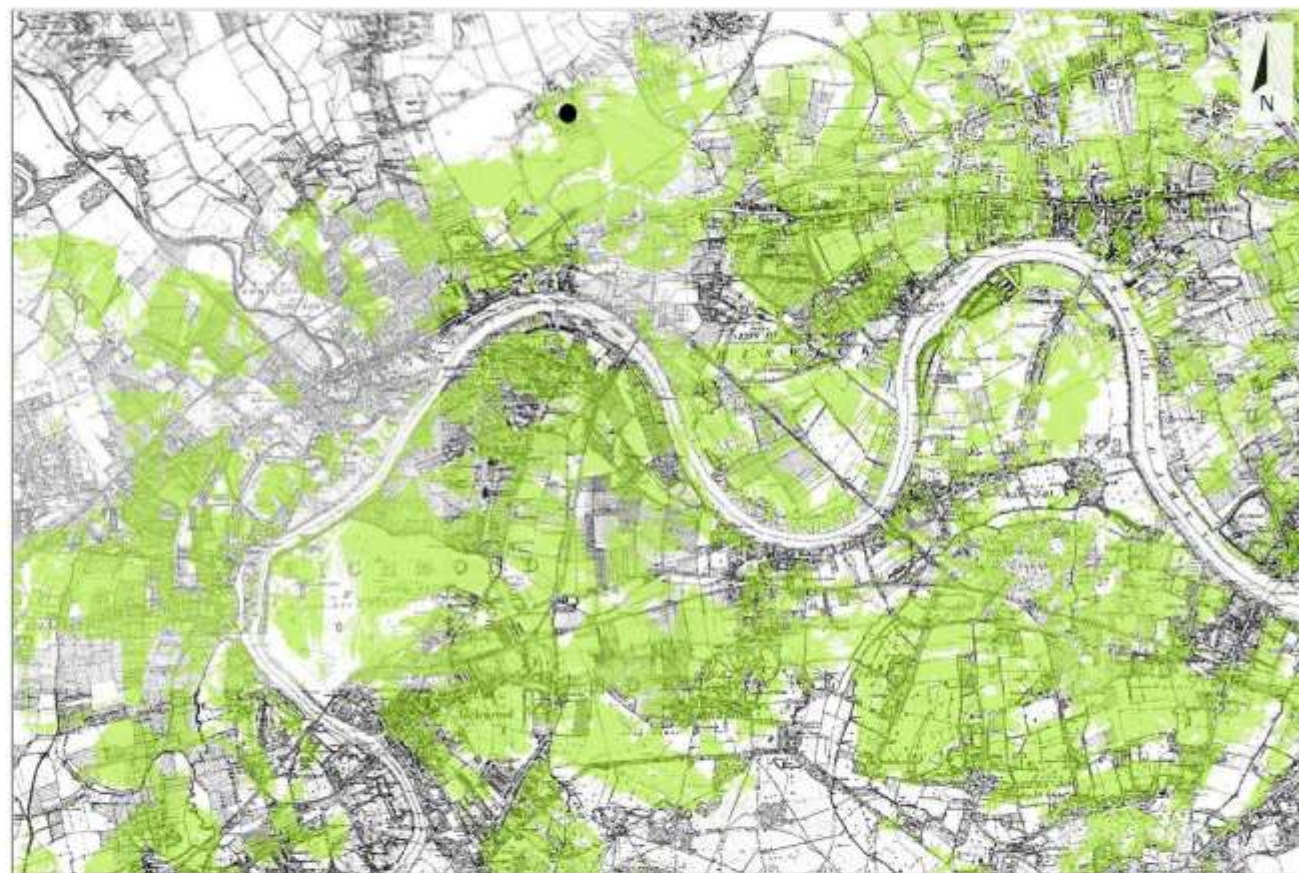
Viewshed Analysis Map

This analysis of the views incorporates viewshed analysis, which is a useful tool for analysing the extent of views from any particular location. Viewshed analysis is a digital mapping technique which allows the ground surface from a particular viewpoint within the landscape to be mapped into two categories – 'visible' from the viewpoint, and 'not visible' from the viewpoint. The viewshed analysis presented here has been created using ArcGIS 10, with a viewpoint of 1.7m high above the ground surface – representing the height of a person standing outside the approximate location of the original mansion (and thus between the two present houses).

The data which creates the viewshed map is taken directly from a contour map, and so does not take into account upstanding features which may act as a barrier to the view, including buildings or tree planting. However, it does give a good general impression of the expansiveness of the view from the terrace which is now limited by recent development and the height of the planting in places.
